New Hampshire Volunteer Lake Assessment Program

2003 Interim Report for Cobbetts Pond Windham

NHDES
Water Division
Watershed Management Bureau
29 Hazen Drive
Concord, NH 03301

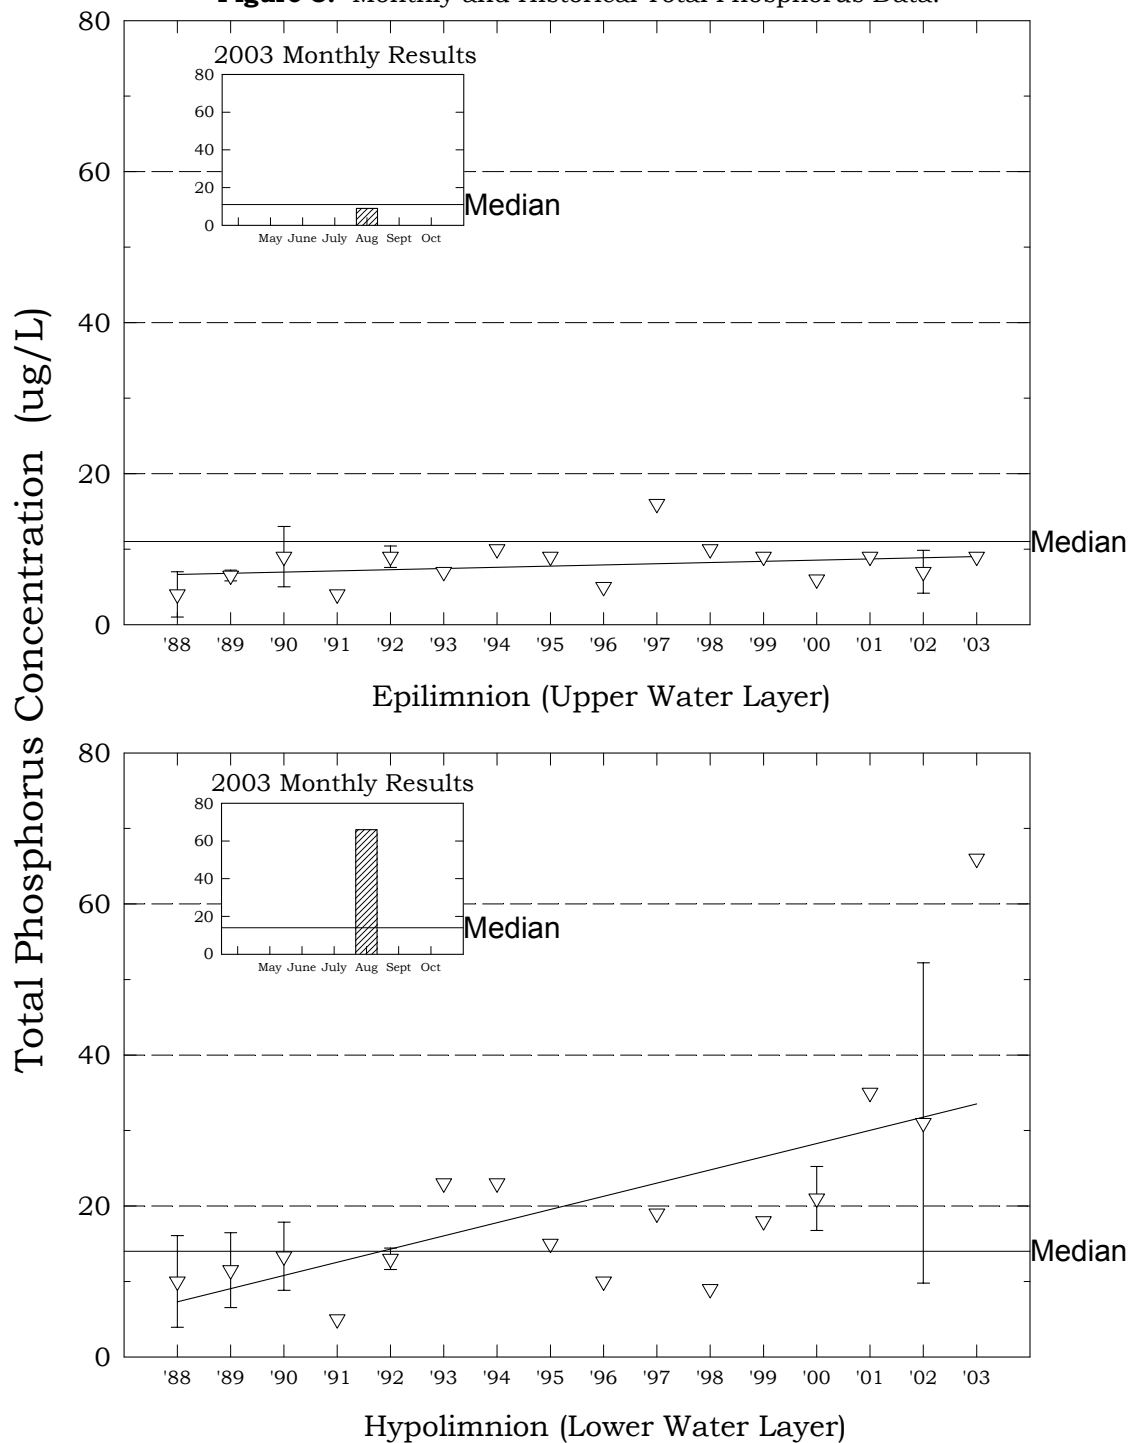
Figure 3. Monthly and Historical Total Phosphorus Data.

STATION 2:

The current year data for the epilimnion (the top inset graph) show that the phosphorus concentration in August was 9 ug/L, which is ***slightly less than*** the state median.

The current year data for the hypolimnion (the bottom inset graph) show that the phosphorus concentration in August was 66 ug/L, which is ***much greater than*** the state median.

Overall, visual inspection of the historical data trend line for the epilimnion shows a ***relatively stable*** phosphorus trend, which means that the concentration has ***remained approximately the same*** in the epilimnion since monitoring began.

Overall, visual inspection of the historical data trend line for the hypolimnion shows ***an increasing*** phosphorus trend, which means that the concentration has ***worsened*** in the hypolimnion since monitoring began.

One of the most important approaches to reducing phosphorus loading to a waterbody is to continually educate watershed residents about its sources and how excessive amounts can adversely impact the ecology and value of lakes and ponds. Phosphorus sources within a lake or pond's watershed typically include septic systems, animal waste, lawn fertilizer, road and construction erosion, and natural wetlands.
